# Insight: Steel Coal Silos – Inspection Practices

## Coal Silo Failures Can be Catastrophic

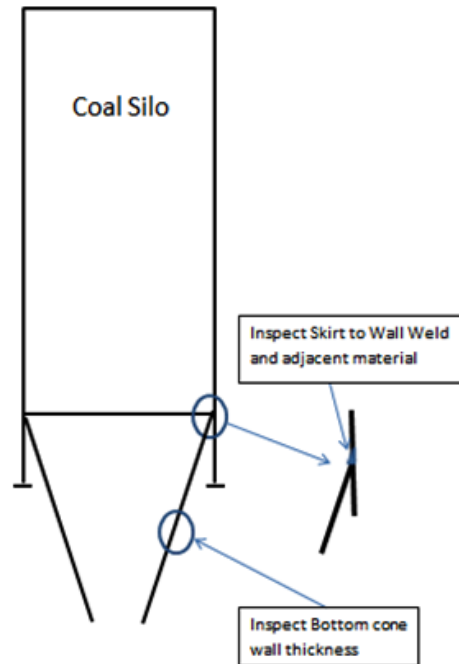
Figure 1 Coal Silo Construction

These failures occurred at attachment weld between the vertical shell of the silo wall and bottom discharge cone. (See Figure 1) As a result, entire silo contents engulfed and damaged plant equipment located below the silo. The most recent failures did not result in human injuries, however if operating personal were in the area, they could have incurred serious injury or death.

Coal is very abrasive. The continuous movement of coal downward wears away at silo walls and conical section. Coal contains Sulphur and carries with it contaminants such as moisture resulting in a corrosive environment that leads to deterioration of attachment weld and silo parent metal. Additionally, the use of bottom cone vibrators and other means to keep coal moving fluidly introduces vibratory mechanical forces to the coal silo which can reduce the fatigue life of silo and result in cracking and failure of the bottom conical section attachment weld.

Coal silos must be completely emptied and inspected for wall thinning and weld deterioration / cracking periodically. Of particular concern is the conical attachment skirt weld that attaches the cone to the vertical wall and the bottom cone. The weld that connects the vertical wall (cone to skirt) weld is particularly susceptible to cracking and can lead to a failure resulting in conical section detachment. This weld must be inspected from inside the silo, via a Bosun chair or scaffolding.
